DRAFT ENVIRONMENTAL ASSESSMENT

Saint Mary's Airport Improvements

State Project Number #Z605630000

October 2021

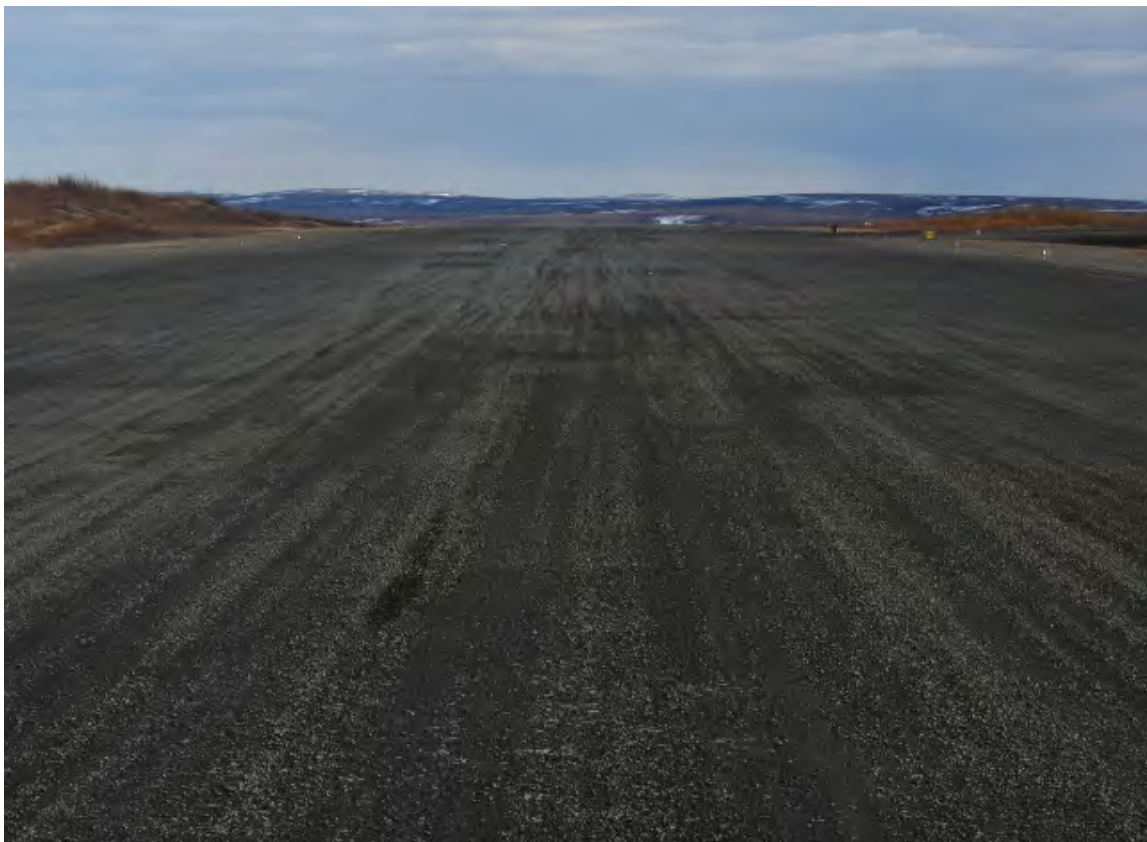
Graphic 1: Current Runway (17/35) Surface

The primary north/south runway (17/35) does not currently meet the FAA 600-foot runway safety area (RSA) standard beyond each runway end and the runway surface has degraded over time (Table 2; Graphic 1).

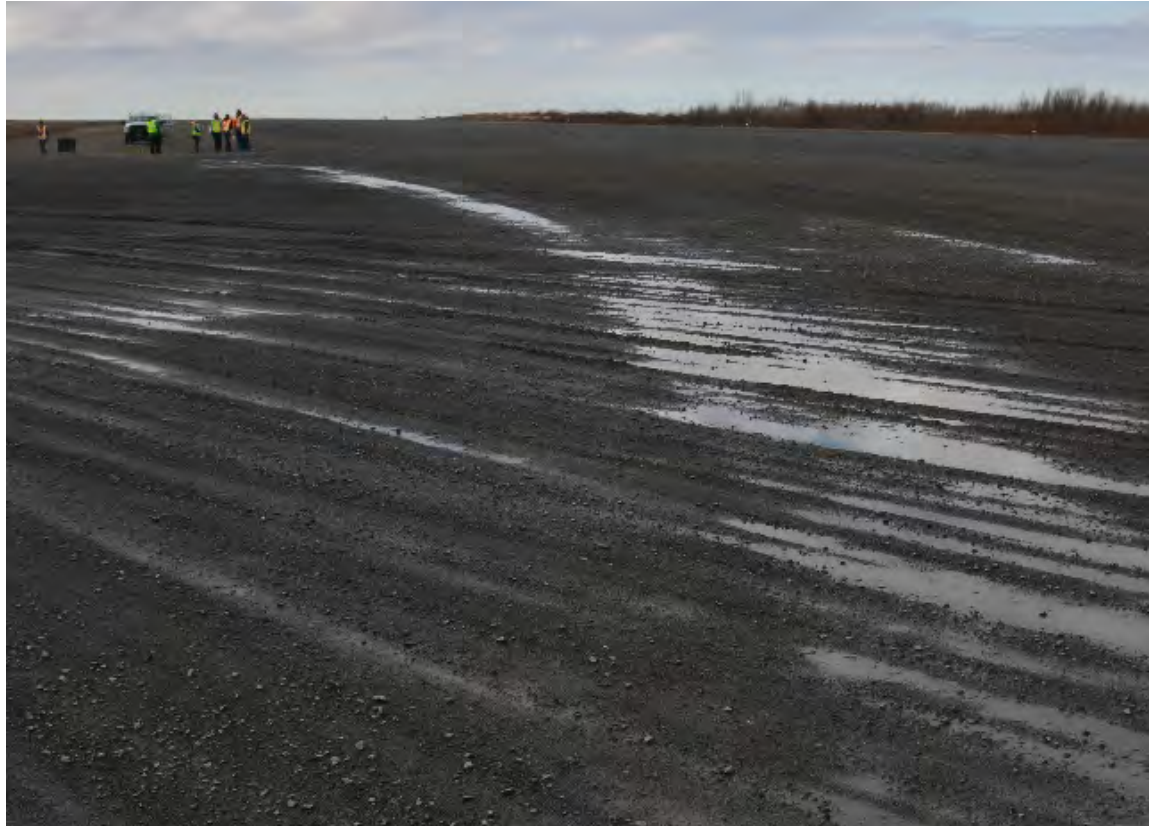
Graphic 2: Current Taxiway B Surface

The cross-wind runway (6/24) does not currently meet the FAA standard safety area width of 150 feet and the runway surface has degraded over time. Taxiway A and B and the transient and main aprons also have degraded surfaces (Table 2; Graphic 2).

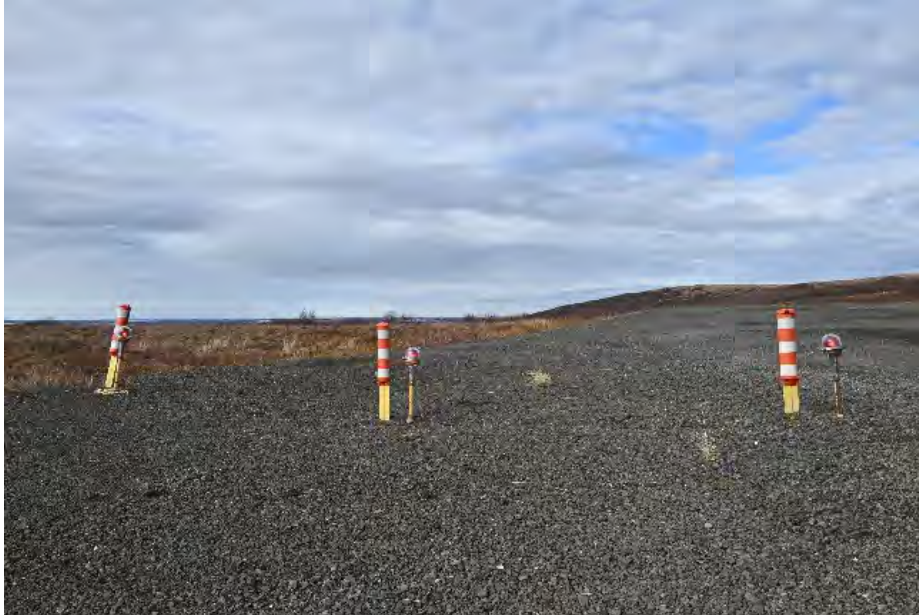
Graphic 3: Current Lighting on Runway 6/24

All runway and taxiway lighting components and most navigational aids are more than 24 years old and at the end of their useful life (Graphic 3). There are existing embankment drainage issues in many locations and water is present in the surface and subsurface of many runway, taxiway, and apron areas (Graphic 4). Drainage ditches around the airport facilities would need to be shifted based on the proposed changes in airport layout. Vegetation within the proposed RSA expansions consists of shrubs and trees which would require clearing to support a new embankment.

All Airport runway and taxiway lighting components, including most navigational aids, would be replaced. The existing Runway 17 approach lighting system would be permanently removed. The segmented circle and lighted wind cone would be replaced and shifted slightly to accommodate drainage ditches. Runway 6/24's supplementary wind cone will be replaced in situ.

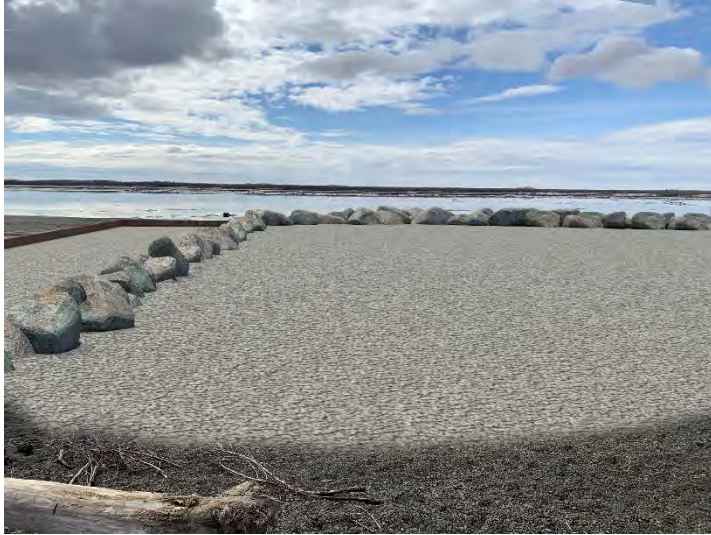
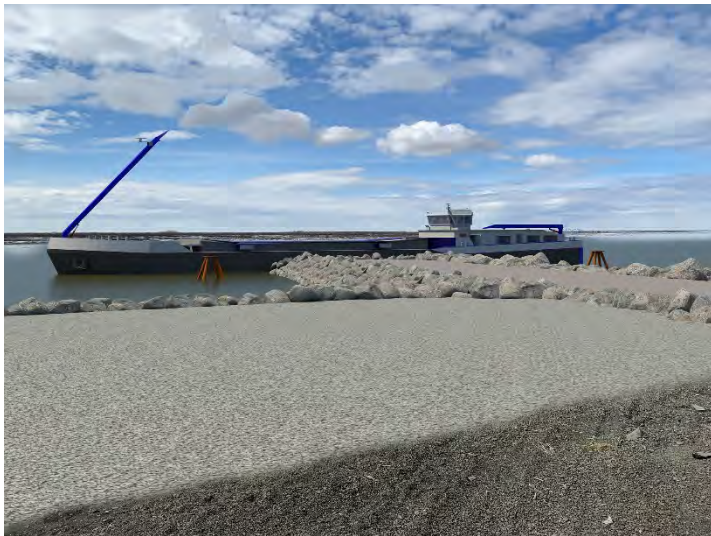
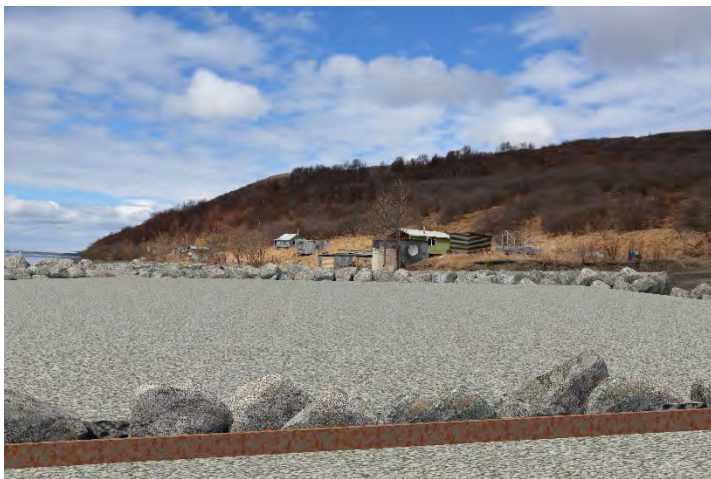
Graphic 5: Proposed Causeway

The proposed design of the temporary barge landing would be a solid fill causeway extending approximately 500 feet into the Yukon River. The causeway would be approximately 65 feet wide at the toe of slope, with a 430-foot-long by 30-foot-wide compacted driving surface and would be constructed primarily from Type A selected granular core material. The upstream 1.5(H):1(V) causeway side slope would be reinforced with geotextile overlaid with a 1-foot-deep Class I riprap filter layer and armored with 2 feet of Class II riprap. An additional 2 feet of Class II riprap would be placed at the toe of the slope. The causeway's downstream 1.5(H):1(V) side slope would have geotextile overlain with 3 feet of Class II riprap. The causeway end would extend another 70 feet into the river at an approximate 5 percent average slope, to approximately 10 feet below ordinary high water (OHW). The causeway end would be protected with geofabric and 2 feet of Class II riprap overlain with 6 inches of sacrificial material. The causeway end toe of slope would be protected with an additional 2 feet of Class II riprap.

Two mooring dolphins would be installed along the causeway. The dolphins would consist of four 10-inch diameter steel piles. Each 50-foot long pile would be driven about 25 feet into the bed of the Yukon River using a vibratory hammer. It is expected that it will take 30 minutes to drive each pile and a single pile will be driven per day. Removal of the piles is expected to take approximately 15 minutes and completed over 3 days. It is expected that a barge (expected to be around 55 feet by 200 feet and 2,500 Tons) equipped with a crane and vibratory hammer pile driver and supported by a skiff would complete the work.

Approximately 50 feet upstream of the causeway, a 10,000-square-foot offloading and staging area would be constructed 8 feet above OHW. The offloading and staging area and the connector area would be constructed of Type A selected granular core material with side slopes armored with geotextile overlain with riprap, as required.

Material imported via the Yukon River would require development of a temporary barge landing and construction of a temporary combination causeway/pile-supported causeway at the airport barge landing site to allow material to be transported up the Yukon River Access Road, approximately 1.3 miles to the airport (Graphic 5). This option may require offloading and staging areas at the airport barge landing site and a new culvert along this existing road. See Appendix A, Figure 3, Proposed Temporary Barge Landing.

Fill would be brought to the Airport Barge Landing and offloading and storage site by truck via the access from a nearby permitted location. A bulldozer would place the material from shore into the river. Riprap would be placed either from a barge or from the causeway and the offloading and staging area using an excavator. It is expected that riprap would be brought to the site as a single barge.

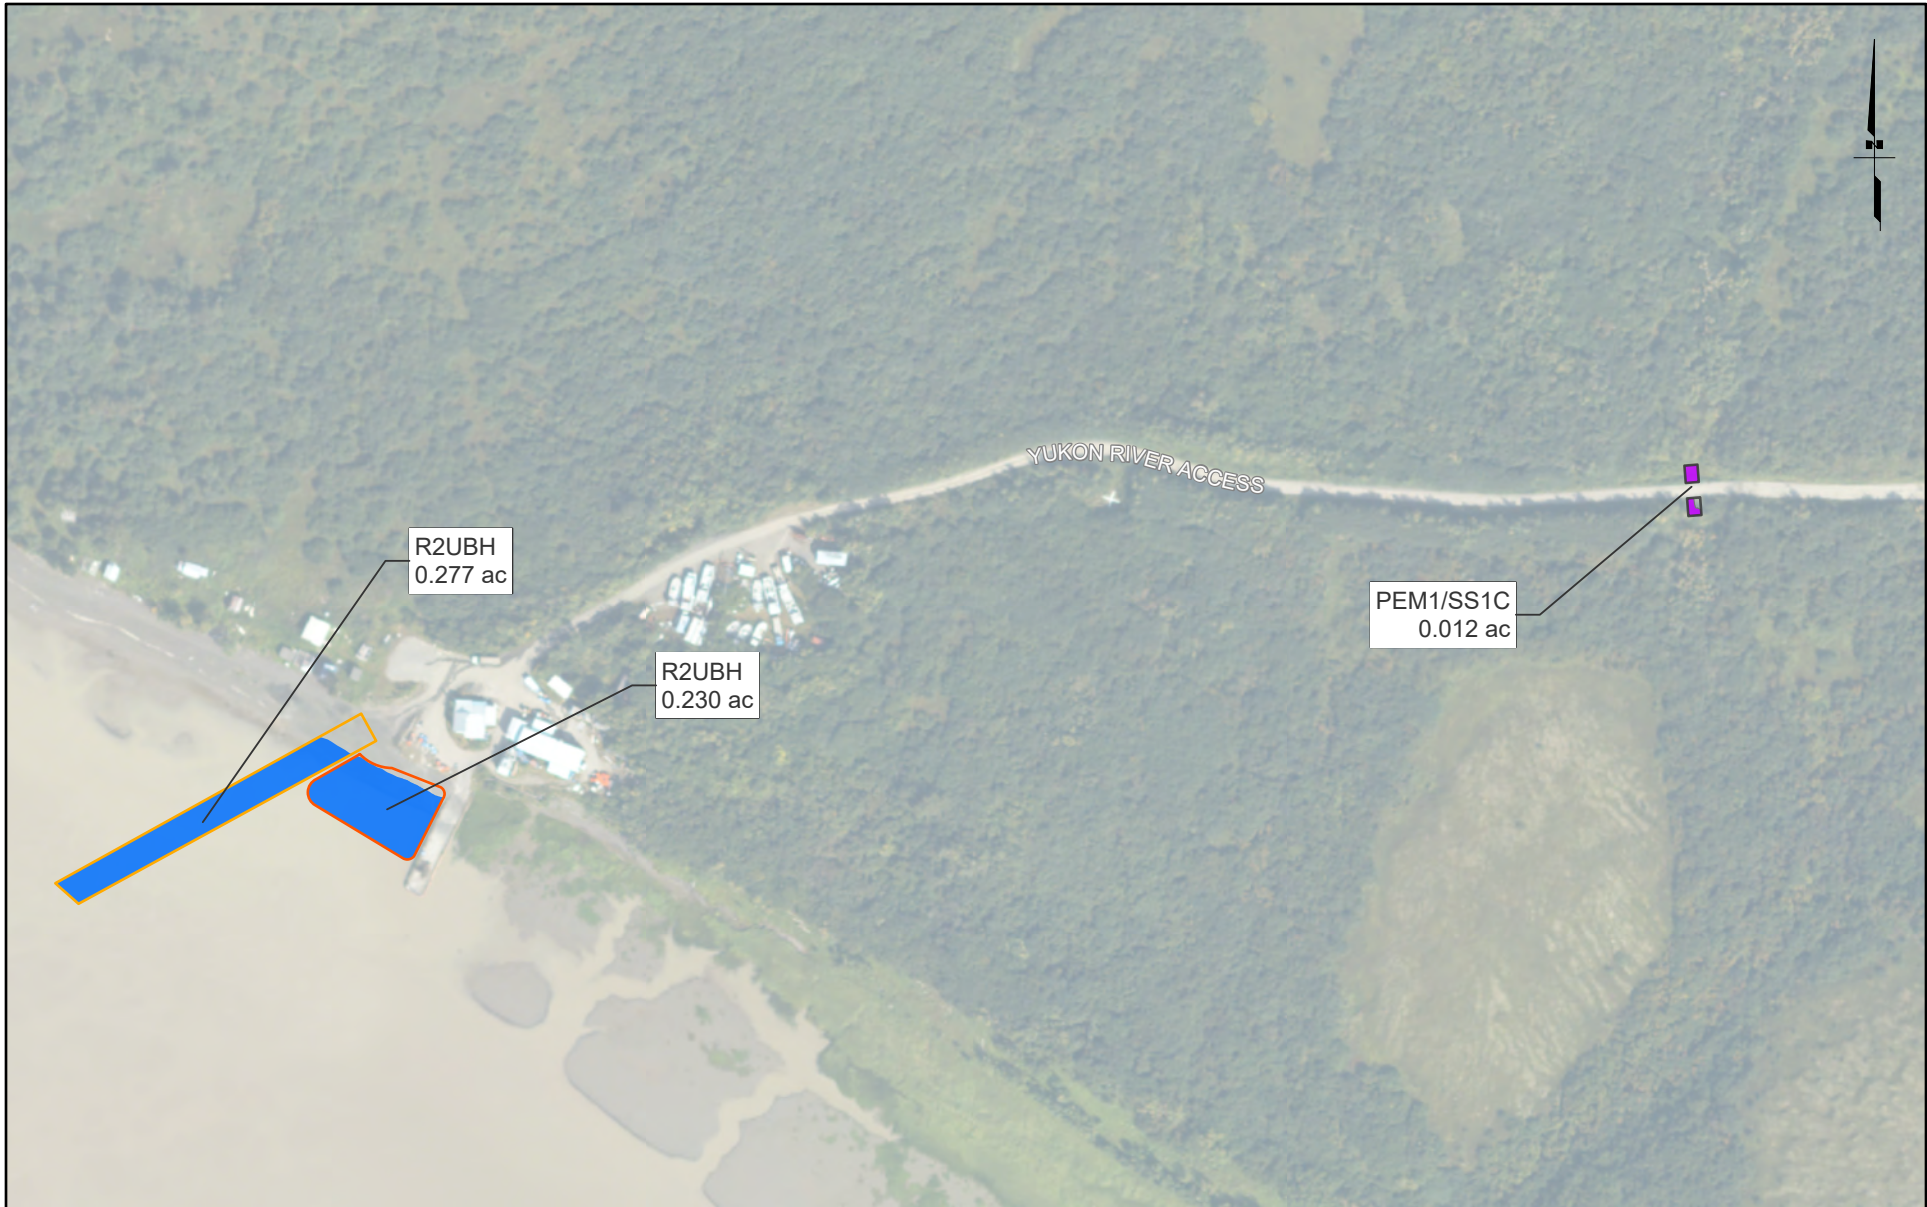
FIGURE 8

Table 7 summarizes effects from the project and are shown on Figure 8 Wetland Impacts (Saint Mary's). To extend and widen the runway safety areas, improve airport drainage, construct the causeway and staging area, and improve the access road between the airport and the causeway, the project would permanently place 48,500 cubic yards (CY) of fill (including select material, Type C, Class I and II riprap, and gravel) into approximately 3.12 acres of wetlands and waters of the U.S. (Table 1).

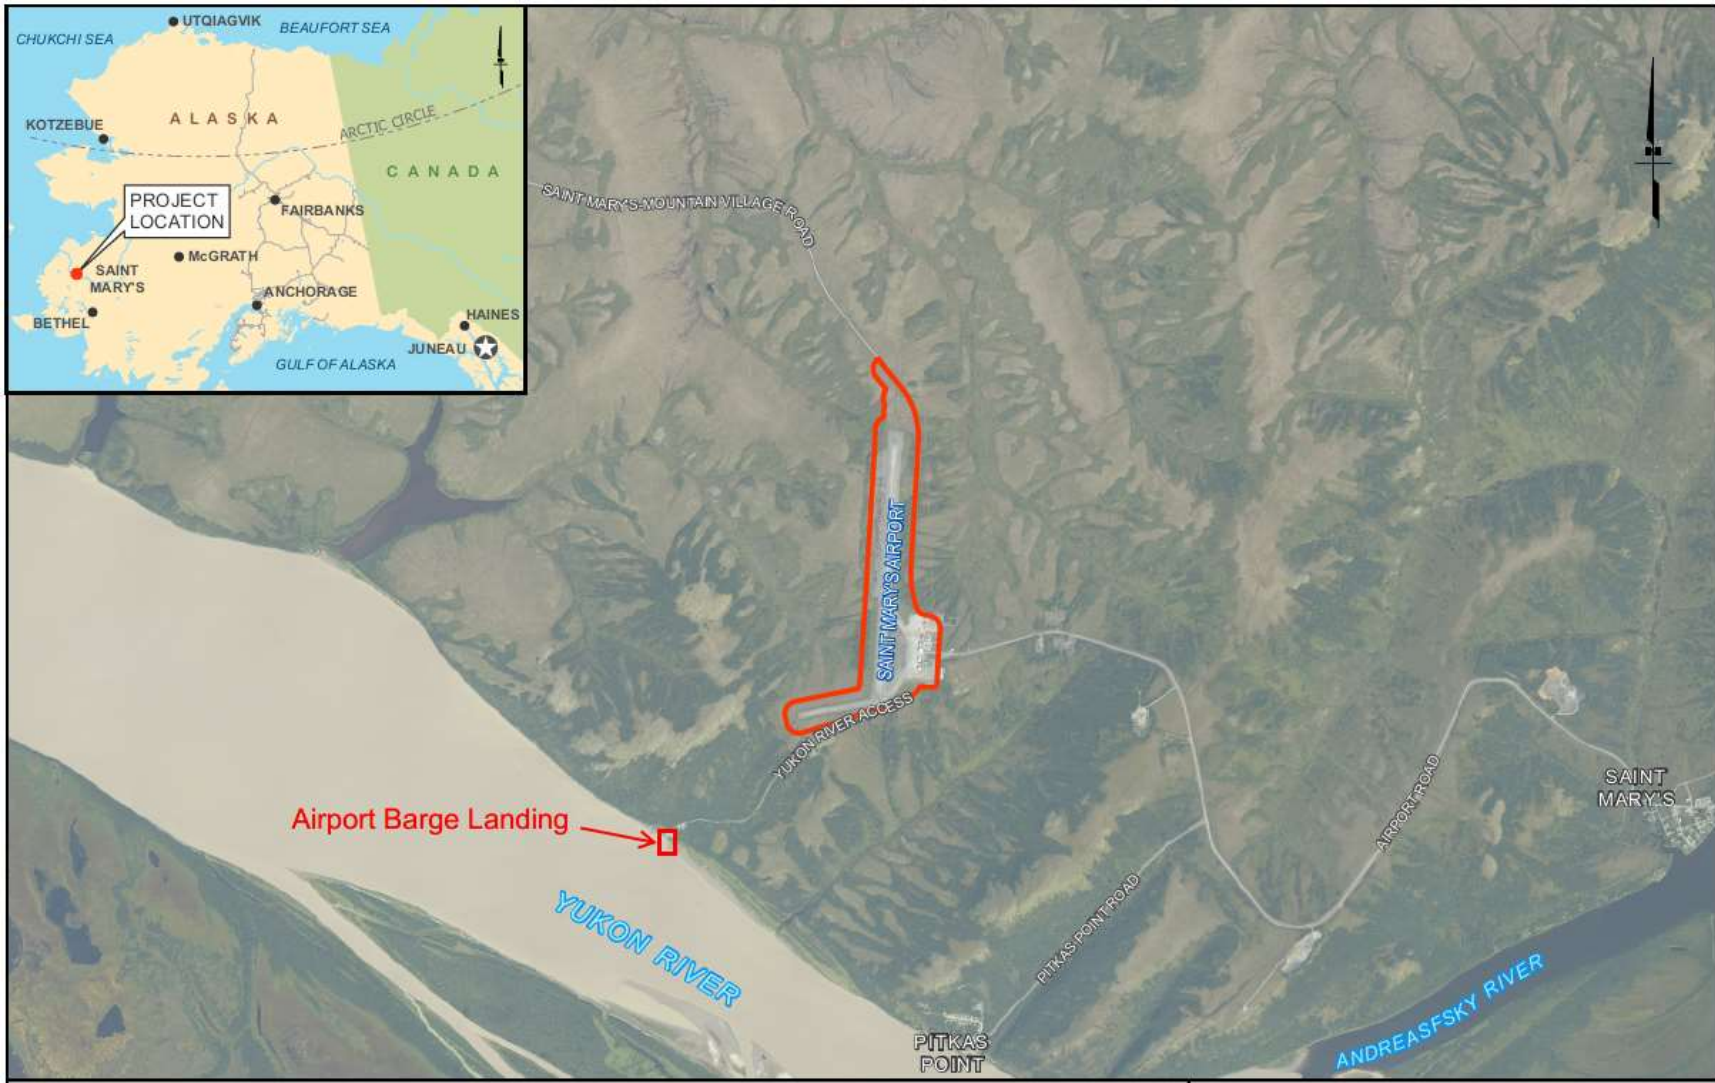
Figure 1. Saint Mary's Airport Barge Landing Location

There is an existing access road to a causeway/dock structure on the north bank of the Yukon River at the airport barge landing adjacent to the Boreal Fisheries site near the airport. While silt has accumulated around the causeway and it no longer extends to deep enough water, the general location is suitable for a new barge landing and staging area.

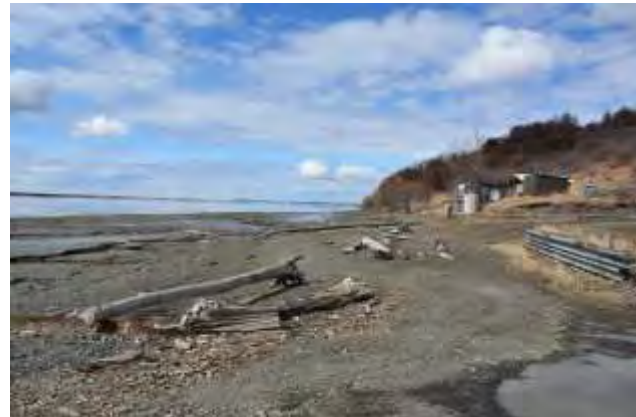
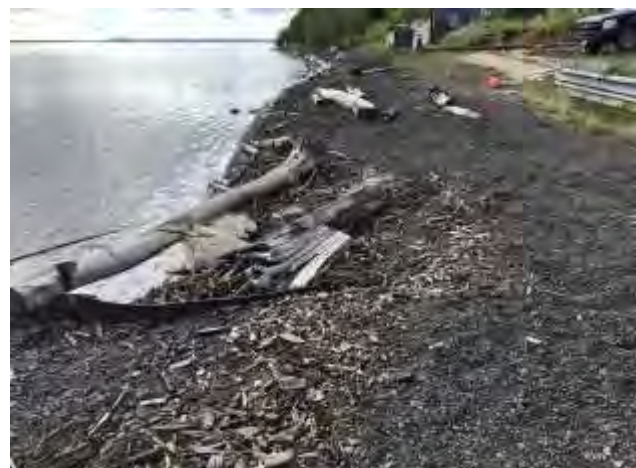
Figure 5. The proposed St. Mary's Airport Barge Landing location on the lower Yukon River in May (above) and June (below) 2021.

At the proposed barge landing location, the Yukon River is approximately 0.75 mile wide. At a river cross section taken on June 26, 1996 at Pitka's Point, the Yukon River had a maximum depth of 40 feet. The velocity on that date and at that location was 3.17 feet per second. The river bottom in this area is primarily sediment and mud. At its mouth, the Yukon River transports about 60 million tons of suspended sediment annually into the Bering Sea (Brabets et al. 2000).

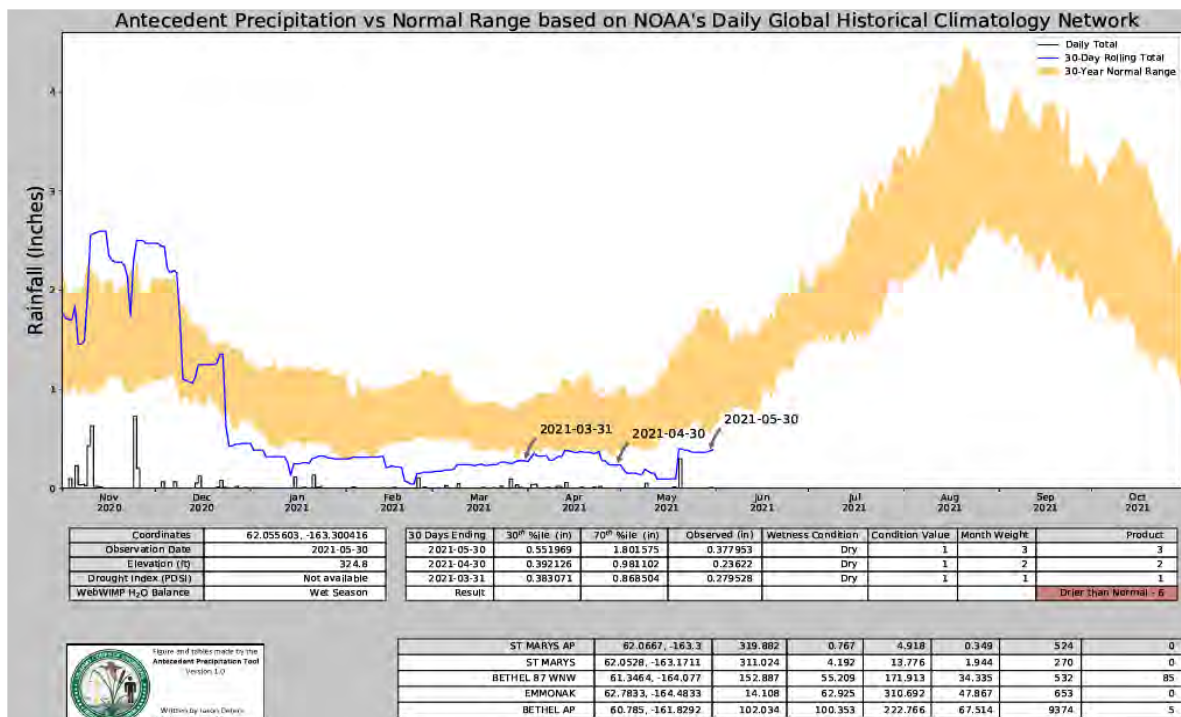
Graphic 5: Bethel NOAA Daily GHCN 2021 Precipitation Data

The Antecedent Precipitation Tool Version 1.0 was utilized using Bethel as the closest station for NOAA's Daily Global Historical Climatology Network (GHCN) (Graphic 5). Daily precipitation values over a 30-day period were analyzed in order to examine the 3-month period preceding data collection activities to determine if surface hydrology or soil moisture conditions observed were drier than normal, normal, or wetter than normal (USACE 2020).

For the 3 months preceding fieldwork, precipitation observations were considered drier than normal (USACE 2020). Conditions immediately prior to the collection of field data in early June were drier than normal. The study area normally receives at least half an inch of rainfall during the month of May. In 2020, the average was well under 0.5 inches. An explanation of how drier conditions impact the delineation is included in Section 4.0.

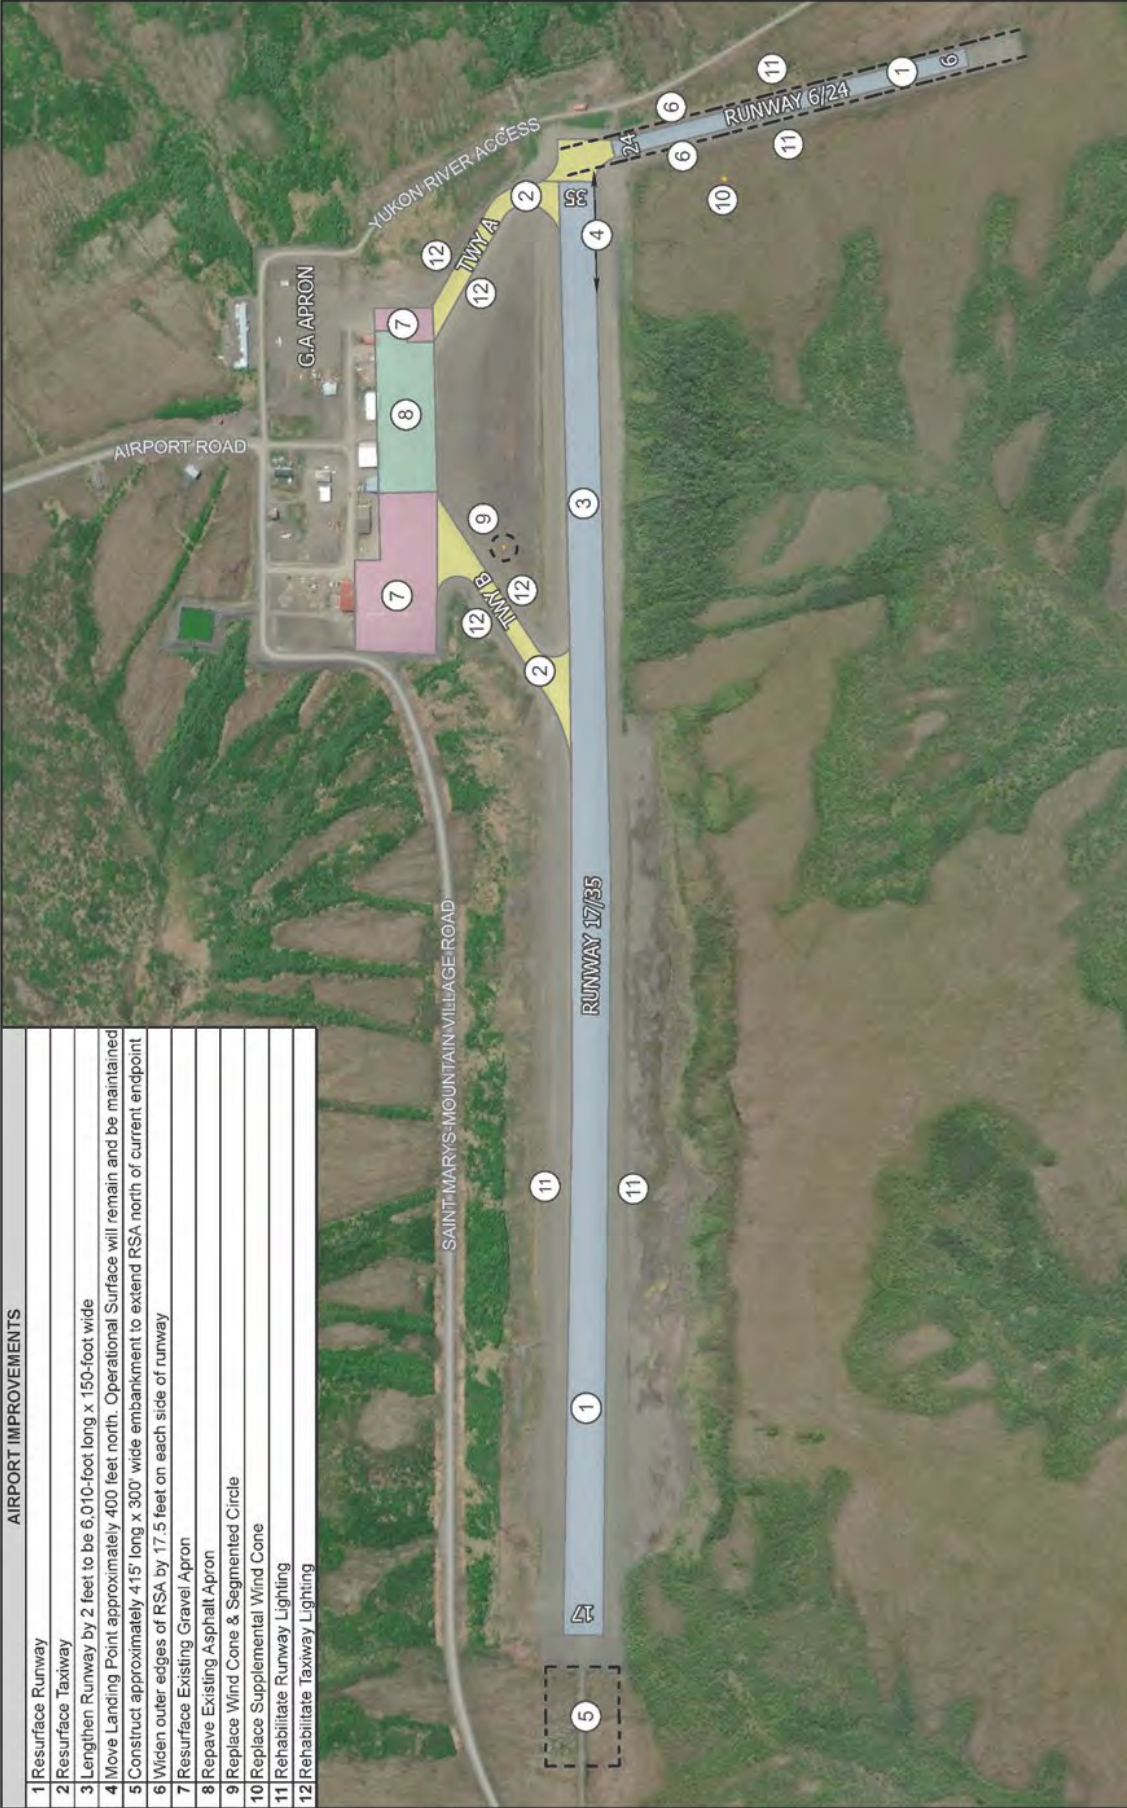
Proposed Airport Improvements

AIRPORT IMPROVEMENTS	
1	Resurface Runway
2	Resurface Taxiway
3	Lengthen Runway by 2 feet to be 6,010-foot long x 150-foot wide
4	Move Landing Point approximately 400 feet north. Operational Surface will remain and be maintained
5	Construct approximately 415' long x 300' wide embankment to extend RSA north of current endpoint
6	Widen outer edges of RSA by 17.5 feet on each side of runway
7	Resurface Existing Gravel Apron
8	Repave Existing Asphalt Apron
9	Replace Wind Cone & Segmented Circle
10	Replace Supplemental Wind Cone
11	Rehabilitate Runway Lighting
12	Rehabilitate Taxiway Lighting
