STATE OF ALASKA
Department of Transportation
and Public Facilities

2022
Alaska Marine Highway System
**SHORE FACILITIES CONDITION
SURVEY REPORT**

Prepared by
Southcoast Region
Marine Engineering Section

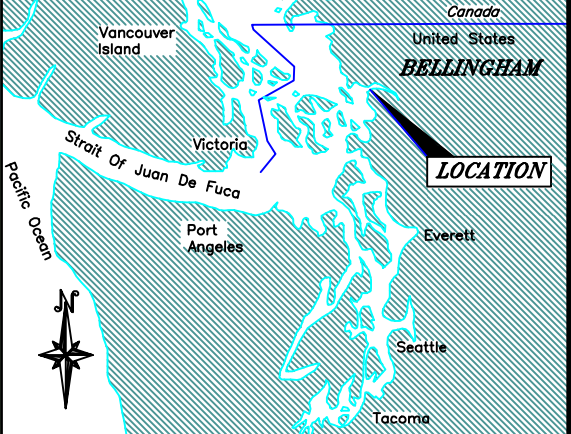
GENERAL LAYOUT
BELLINGHAM

Terminal Description: Bellingham Ferry Terminal, built in 1989, is the southern terminus for the Alaska Marine Highway System (AMHS). Bellingham is a stern-loading facility consisting of a steel transfer bridge, supported by a steel framed lift tower and counterweight system at the seaward end, with two stern dolphins and five breasting dolphins connected by timber catwalks. The terminal building differs from AMHS owned facilities in that it is a multiple use facility. The terminal building lies on a concrete dock supported by steel pipe piles. The dock extends around the northern, eastern, and western faces of the terminal building. The staging area has separate long and short term parking areas. Bellingham’s past 10 years of total passenger and vehicle traffic are shown below.

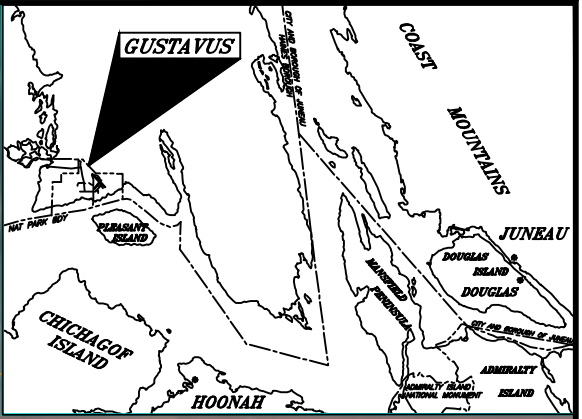
**GENERAL LAYOUT
GUSTAVUS**

Operation and maintenance responsibility is shared among ADOT&PF (freight dock & trestle), AMHS (transfer bridge & mooring structures) and City of Gustavus (small boat harbor facilities). There is no terminal manager but operation of the transfer bridge and line handling is provided by a contract agent.

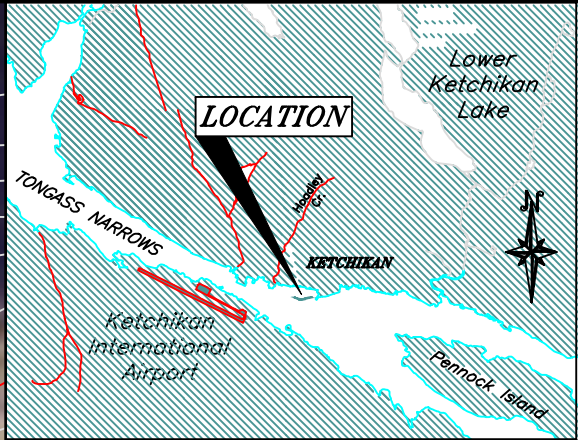
**GENERAL LAYOUT
KETCHIKAN - BERTH I**

Ketchikan is one of the primary service terminals along the AMHS Route, providing northbound connections for mainline service to Wrangell, Petersburg, Sitka, Juneau, Haines and Skagway; southbound connections to Prince Rupert and Bellingham; and hub service to Prince of Wales communities, and Metlakatla. The majority of vessel services and crew changes occur at the Ketchikan terminal.

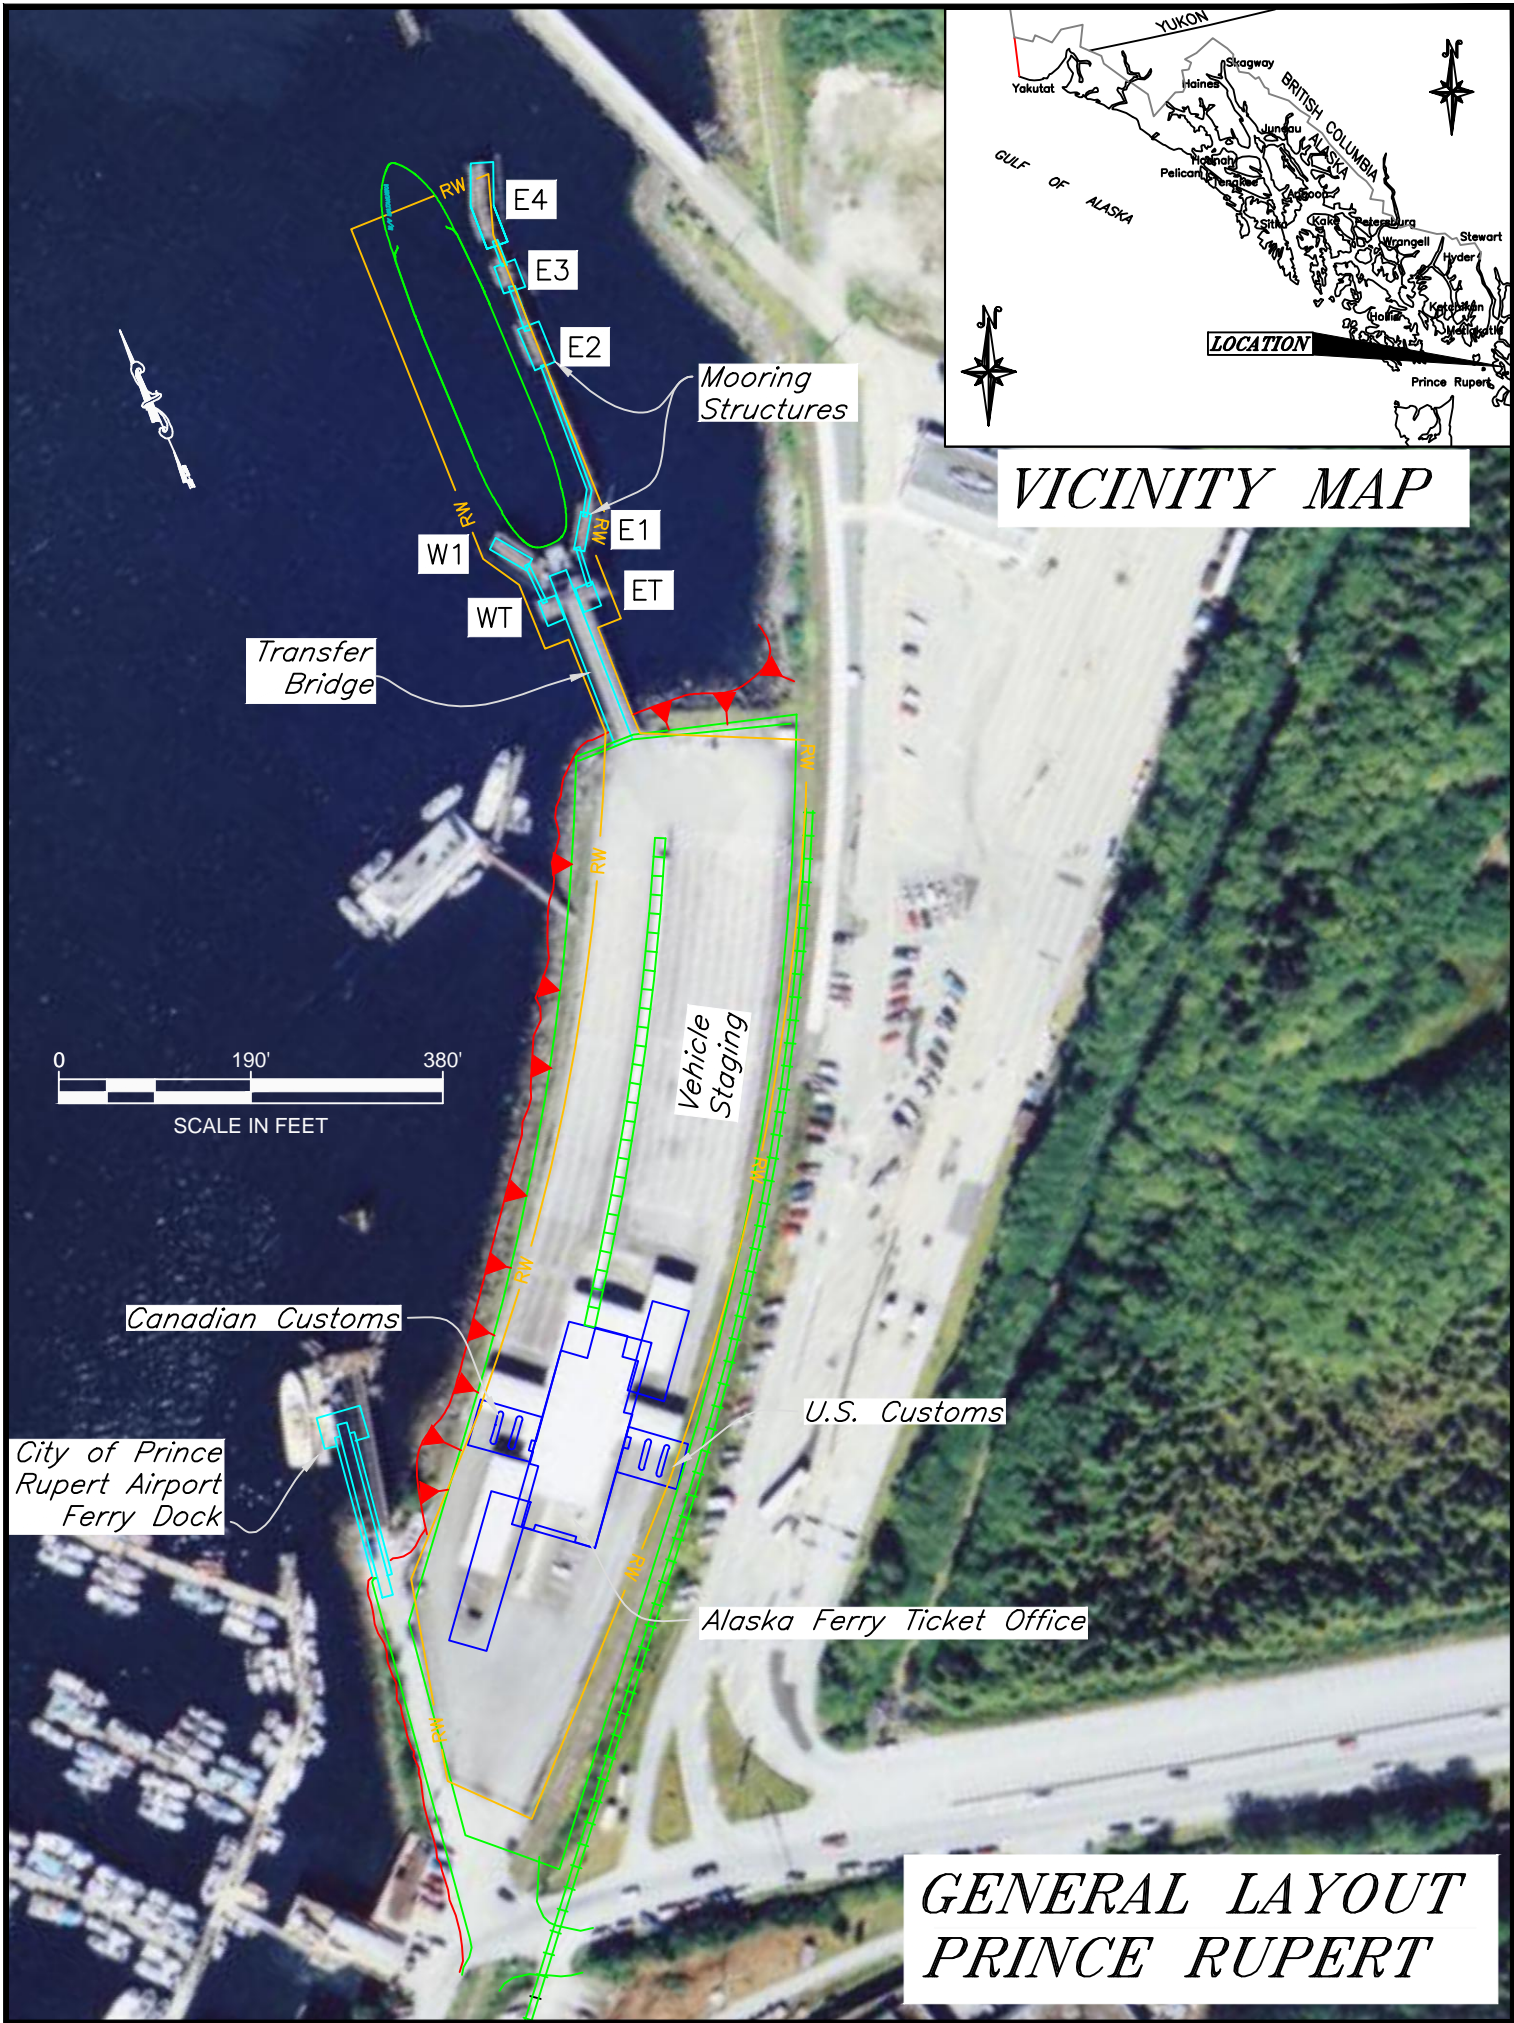
*GENERAL LAYOUT
PRINCE RUPERT*

Terminal Description: Prince Rupert Ferry Terminal is a stern-loading facility consisting of a timber transfer bridge, supported by a timber framed lift tower and counterweight system at the seaward end, with two timber stern dolphins, and three timber breasting dolphins connected by timber catwalks. Uplands include a terminal building built in 1992, with US & Canadian customs stations, paved parking and overhead lighting. The facility was originally constructed in 1963 to service AMHS vessels. Terminal is owned by the Prince Rupert Port Authority (PRPA). The City of Prince Rupert also had interest in the terminal building. As of April, 2013, AMHS now leases the entire facility under a fifty-year term for exclusive AMHS operations. AMHS is now responsible for all operation and maintenance of the marine and upland structures.

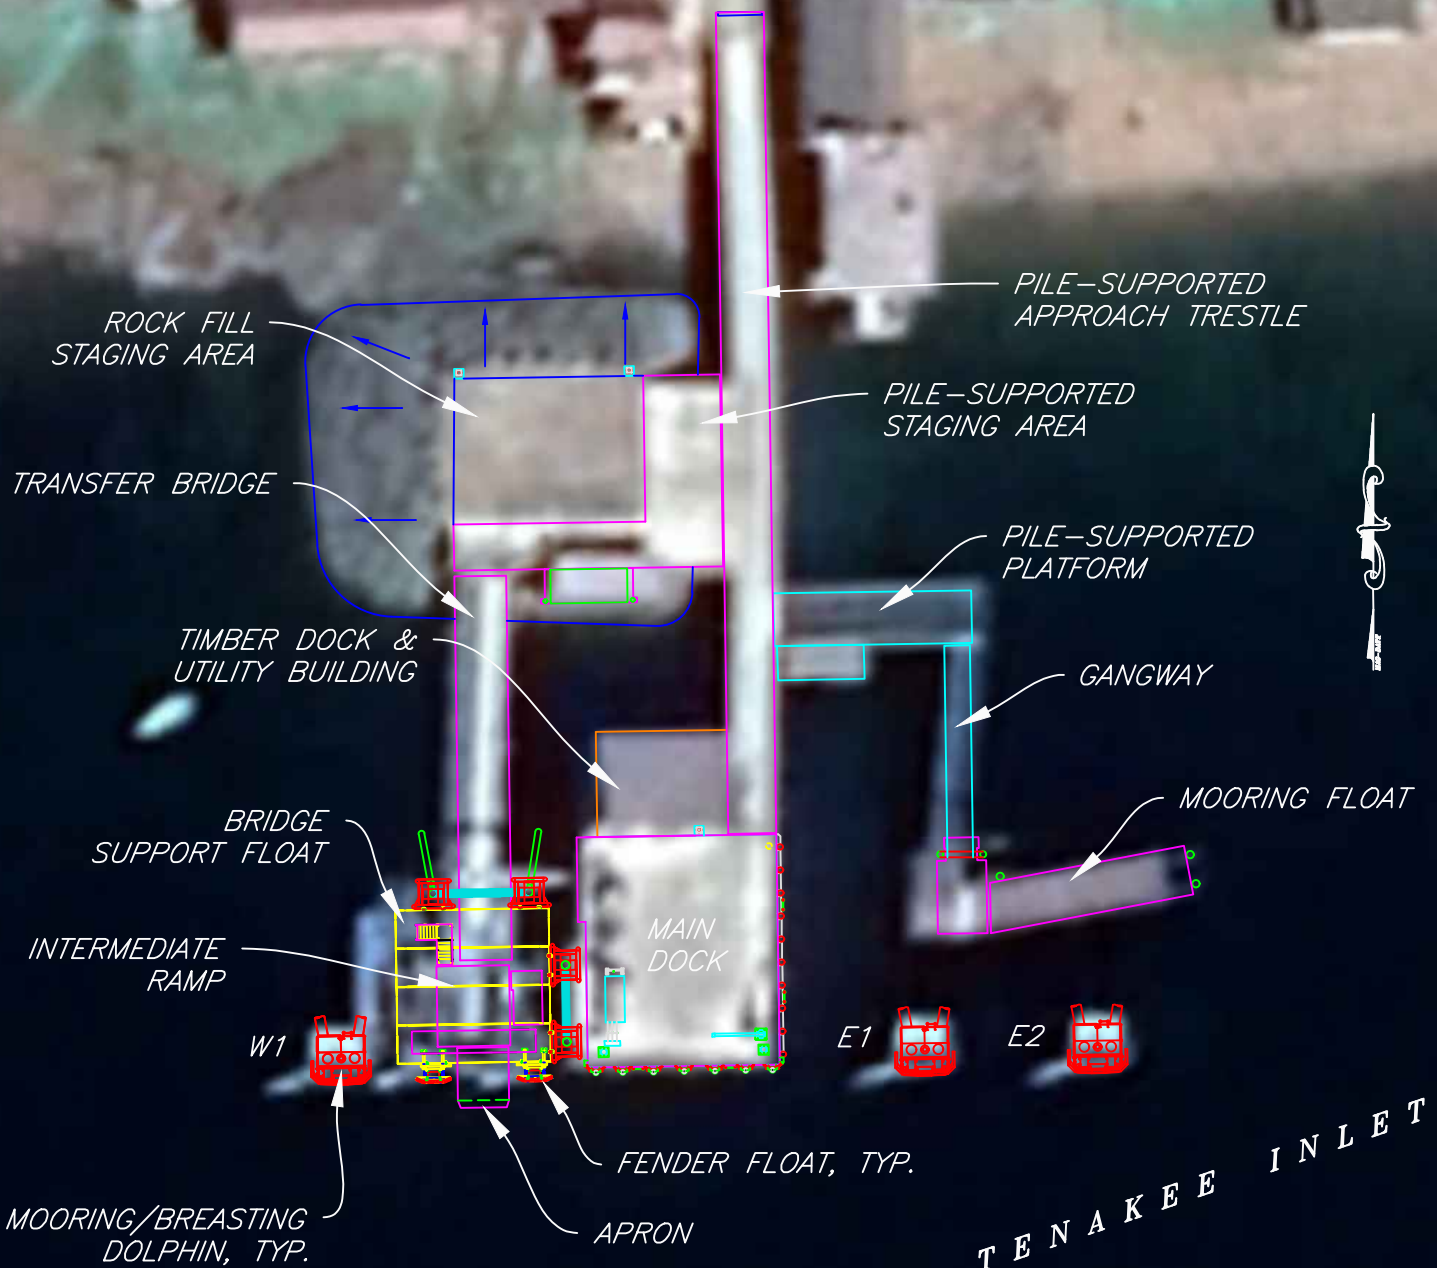
TENAKEE INLET
GENERAL LAYOUT
TENAKEE

A concrete paneled steel pile-supported dock extends west perpendicular to the approach dock and connects a gravel pad to the steel grate transfer bridge to the south. This area also supports the waiting shelter. The transfer bridge extends southward from the gravel pad to a steel pile-supported float equipped with two UHMW fenders, supporting an intermediate ramp leading to a hydraulic-powered apron, providing vehicle and passenger access to the AMHS terminal. AMHS vessels are supported by three steel pile mooring/breasting dolphins, one west of the support float and two east of the main dock, each equipped with UHMW fenders.

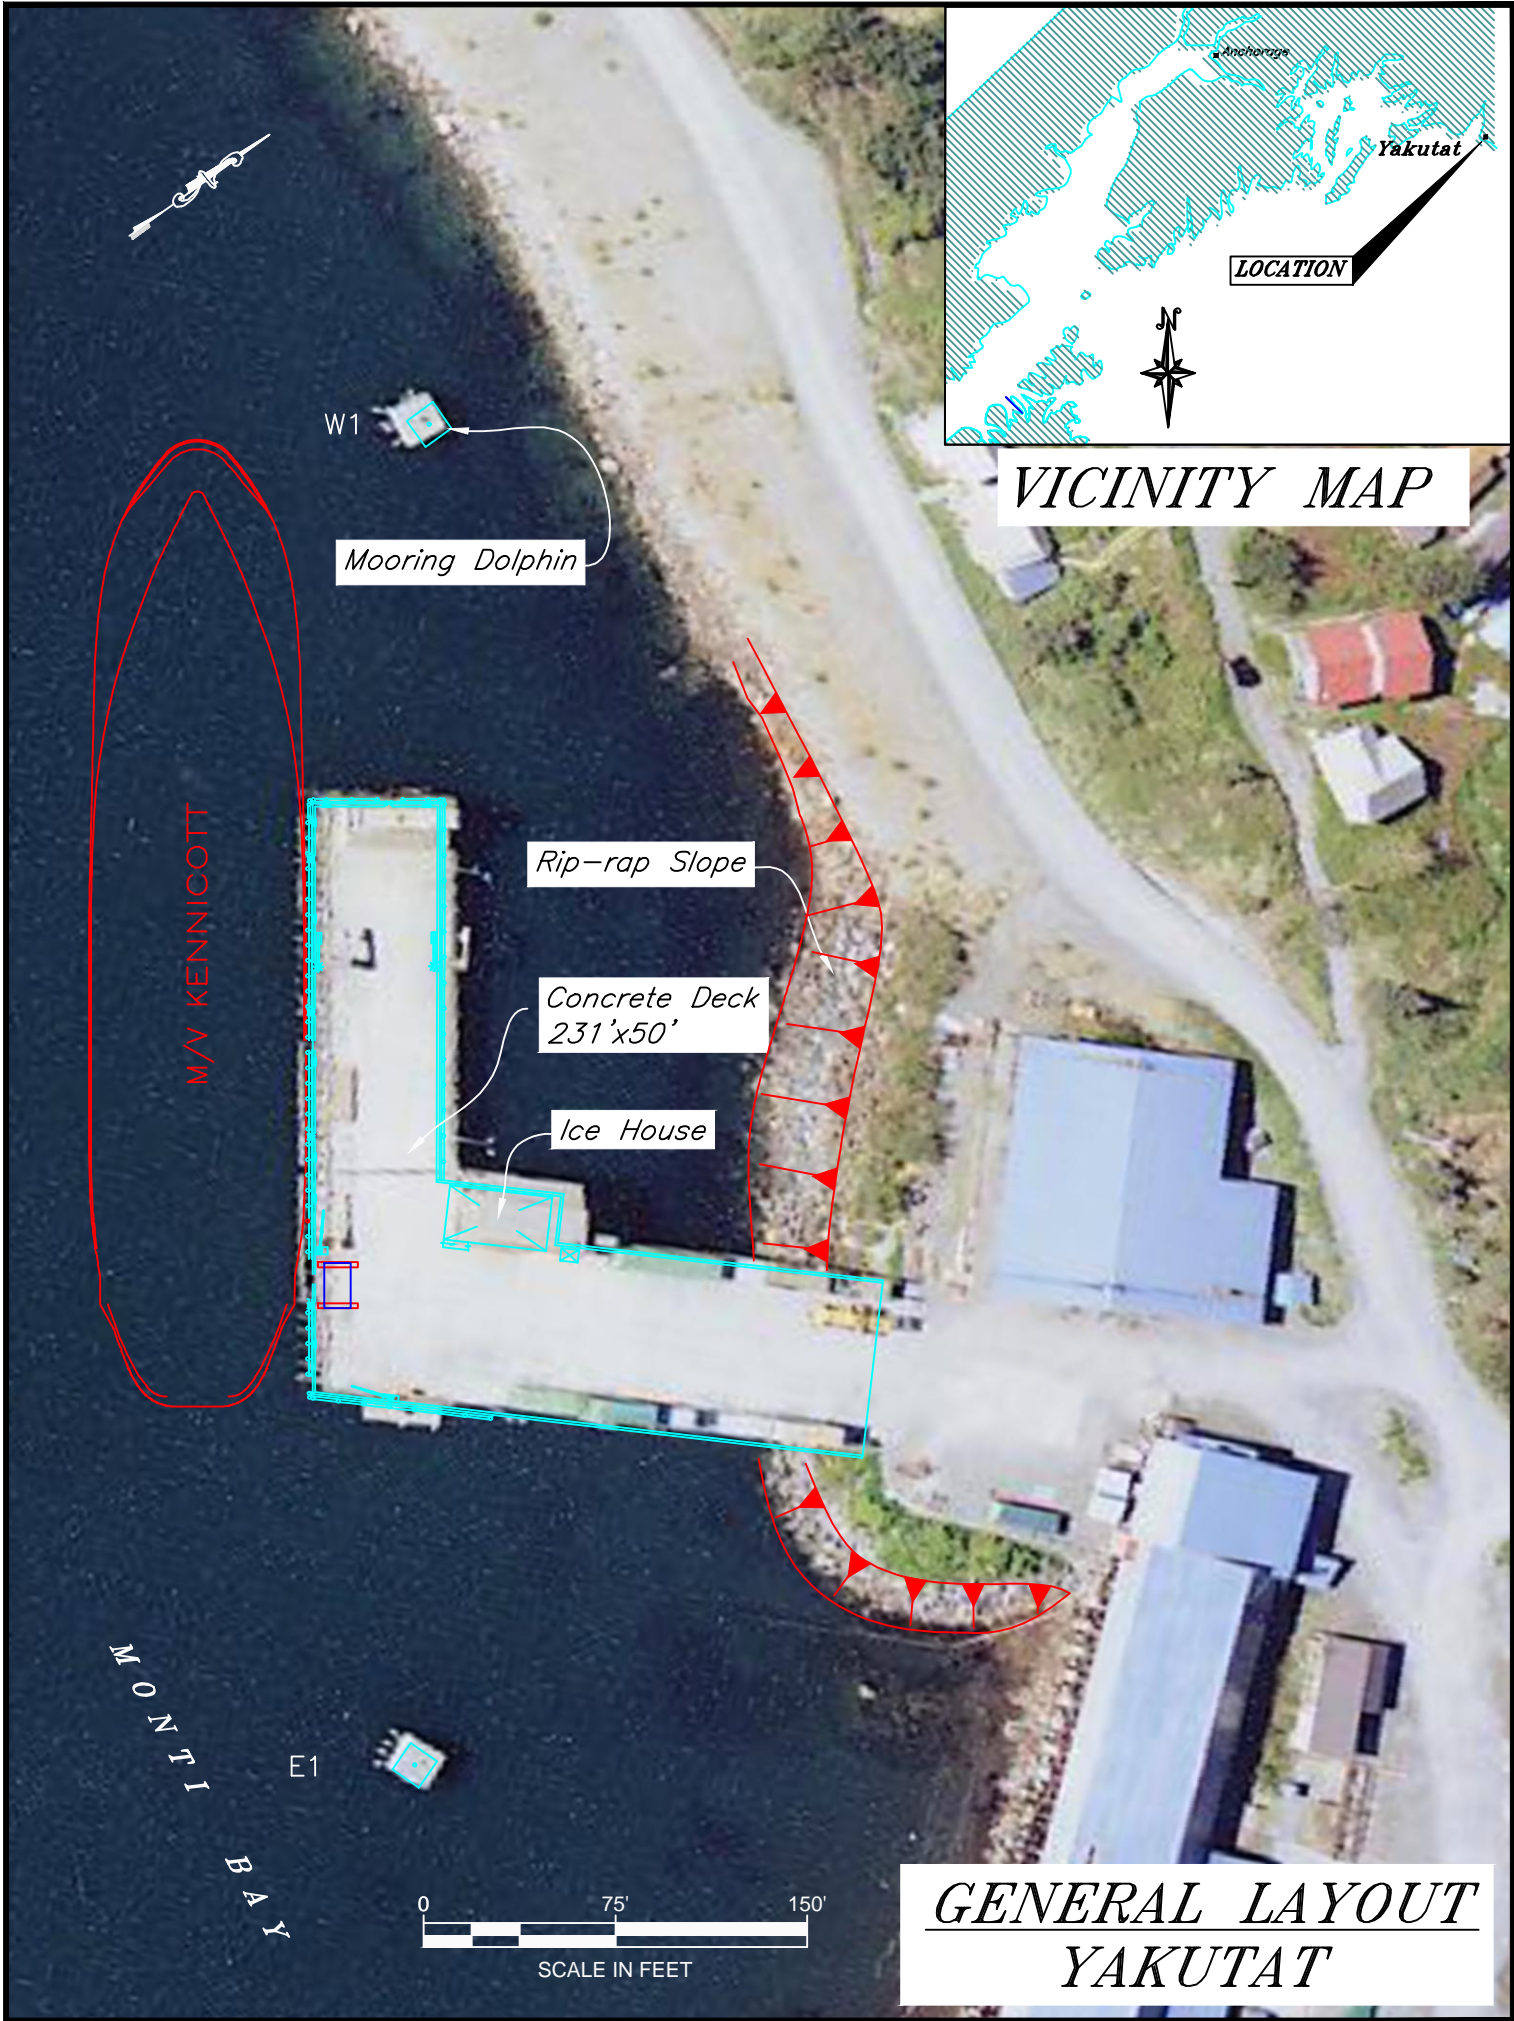
*GENERAL LAYOUT
YAKUTAT*

Terminal Description: The M/V KENNICOTT calls in Yakutat during its cross-gulf trips. The dock is L-shape in plan with a face 237 feet long by 50 feet wide and an approach 70 feet wide by 169 feet long. The dock is constructed of precast concrete deck panels atop cast-in-place concrete caps and steel support piles. Two mooring dolphins are located at each end of the dock and lie off-line from the dock face. The facility is a multi-purpose dock and could be in use by other vessels when the ferry arrives. AMHS is not in control of the operation or maintenance of this facility. The past 12 years of total passenger and vehicle traffic at Yakutat is shown below. The KENNICOTT began its service in 1998.

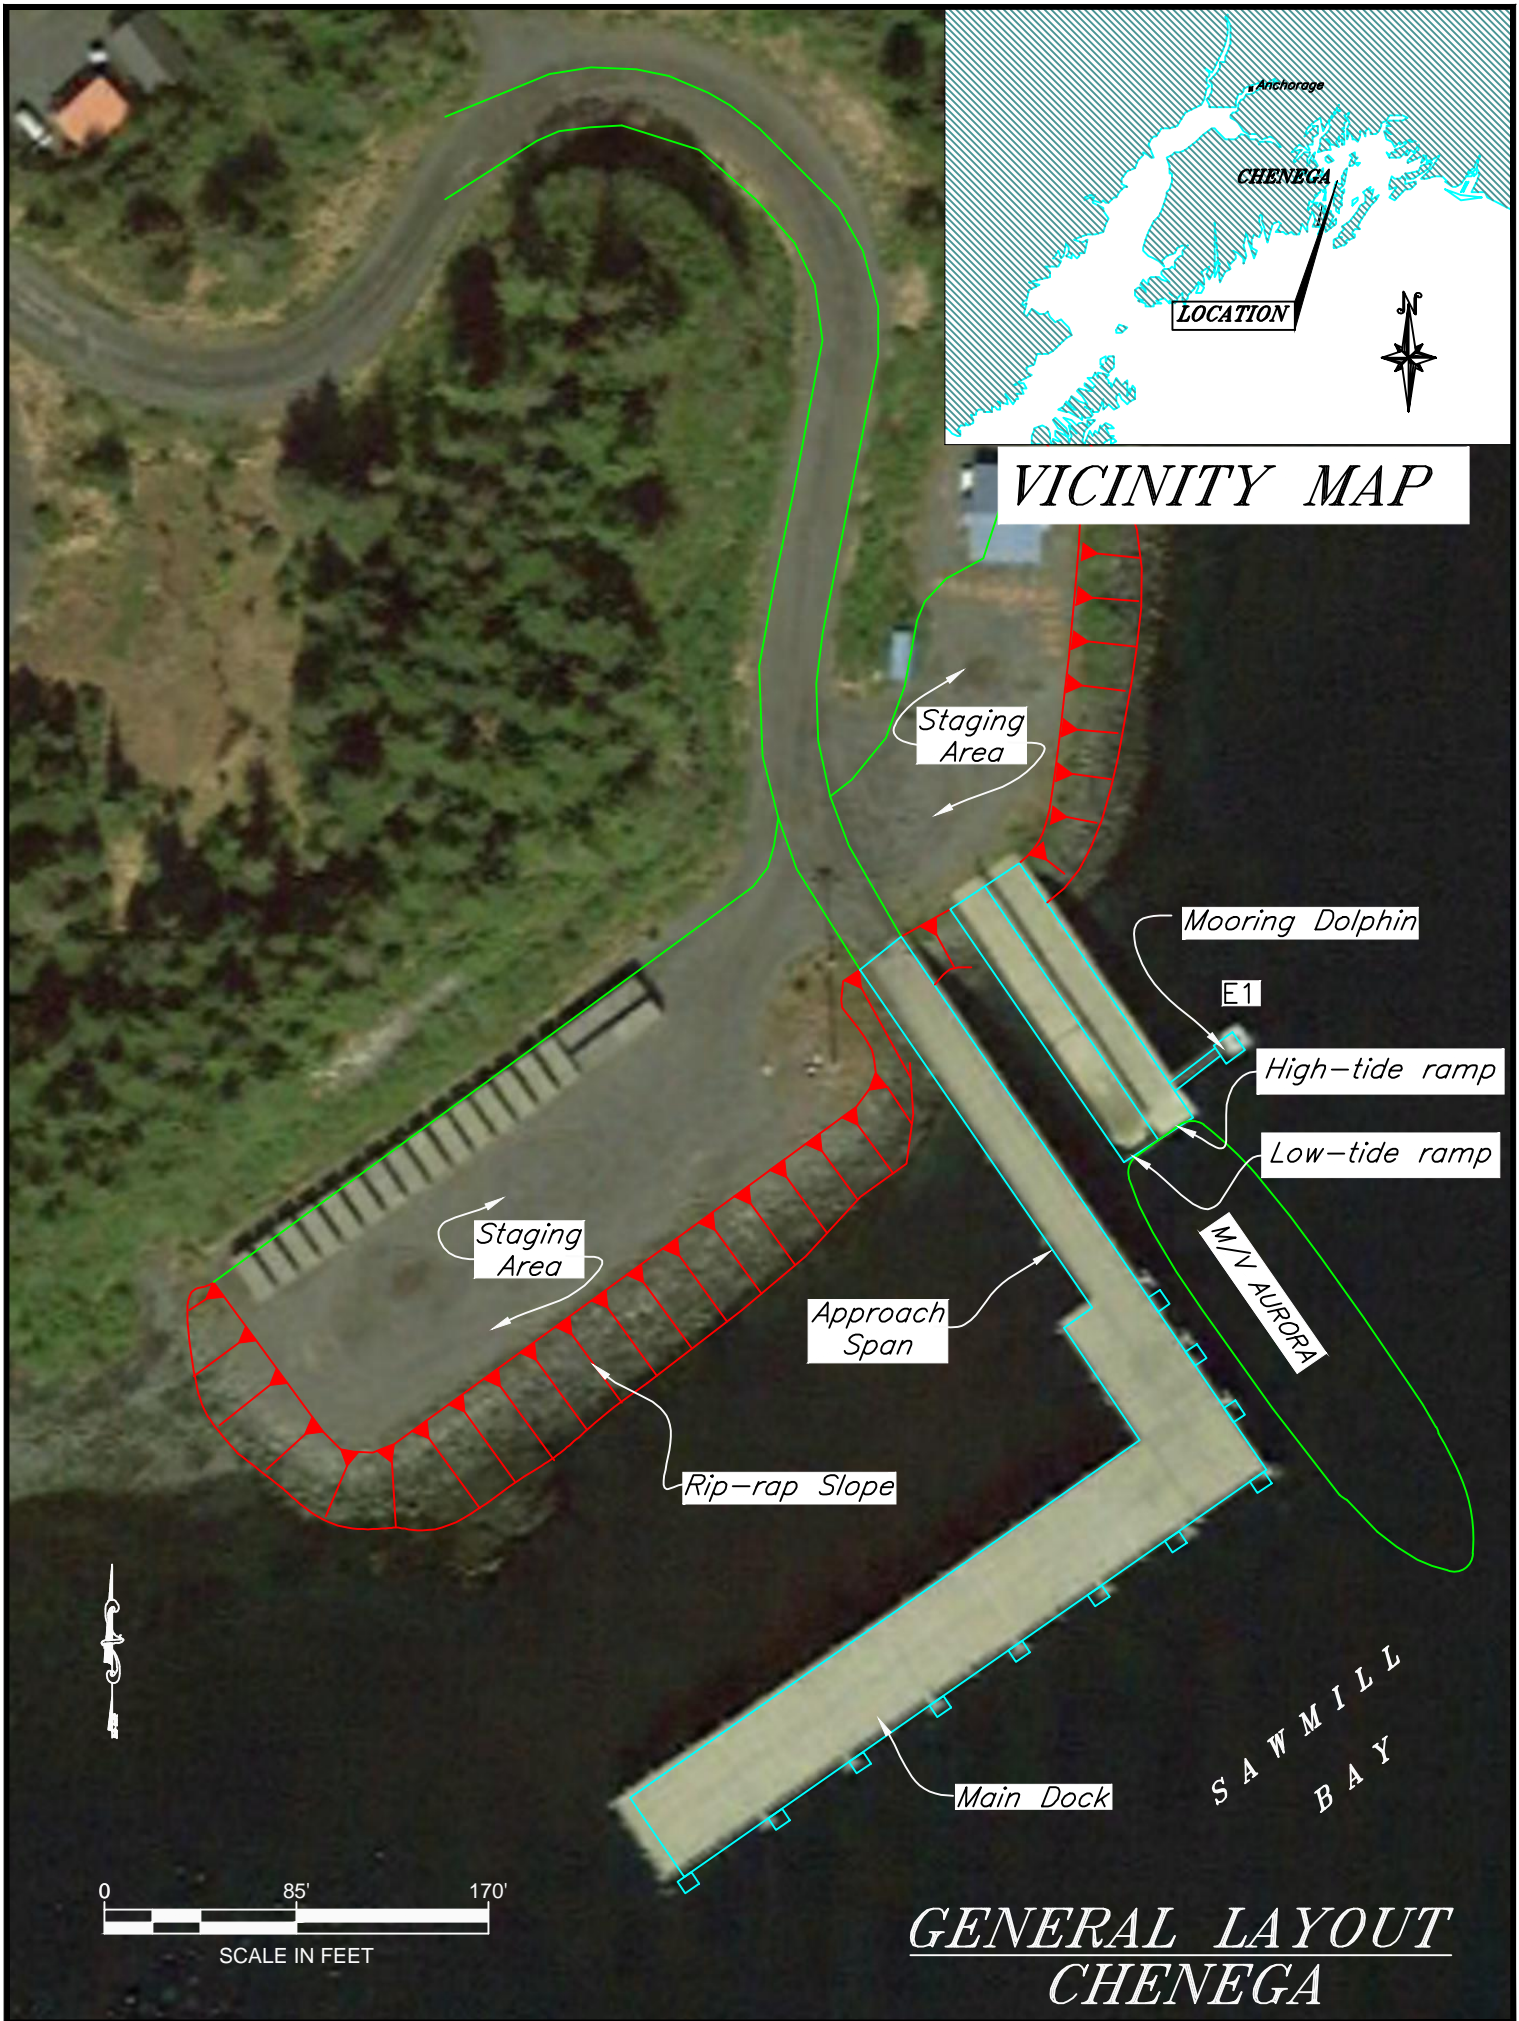
Terminal Description: The Chenega dock and tidal ramps were originally constructed in 1995 to provide a terminal for the BARTLETT. The State of Alaska transferred ownership to the North Pacific Rim Housing Authority (NPRHA) in October, 1998. The Chenega facility consists of an approach, dock and two tidal ramps constructed of prestressed concrete panels welded to bridge beams supported by steel pipe piles socketed to the underlying bedrock. The M/V Tustumena has used the east face of this dock for moorage, while the M/V AURORA uses the tidal ramps located along the north face of the dock for stern loading. The past 12 years of total passenger and vehicle traffic at Chenega is shown below. The global pandemic caused the drop in 2020.

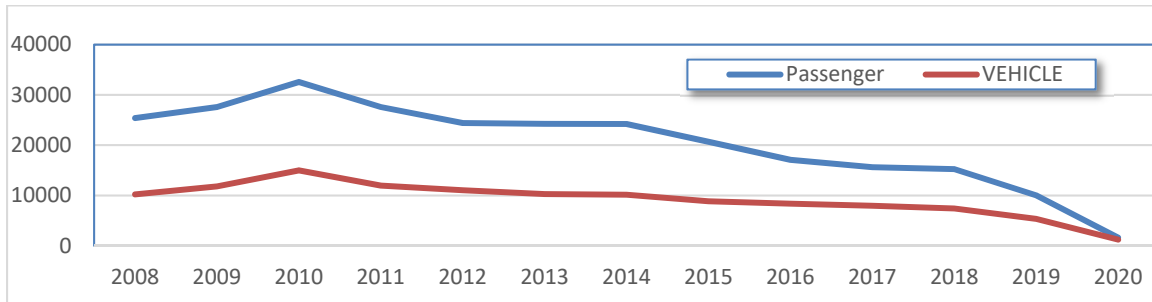
Terminal Description: This terminal provides both side and stern berths for AMHS vessels M/V Aurora and the Alaska Class Ferry (ACF). The marine facilities consist of a 40'-long approach span (pile supported), transfer bridge, intermediate ramp with articulating apron and (6) berthing/mooring structures for the side berth, and a 150-ft long approach span (float supported) to an intermediate ramp with articulating apron and (6) berthing/mooring structures for the stern berth. The stern-berth was originally built as a homeport the Fast Vehicle Ferry (FVF) M/V Chenega, which is no longer in service. The past 10 years of total passenger and vehicle traffic at Cordova is shown below.

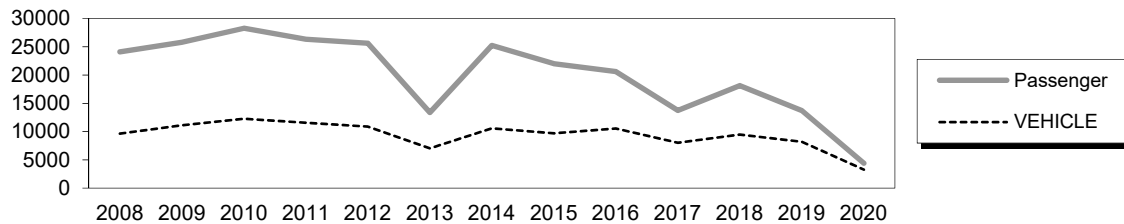
The past 12 years of total passenger and vehicle traffic at Homer is shown below. The global pandemic caused the drop in 2020.

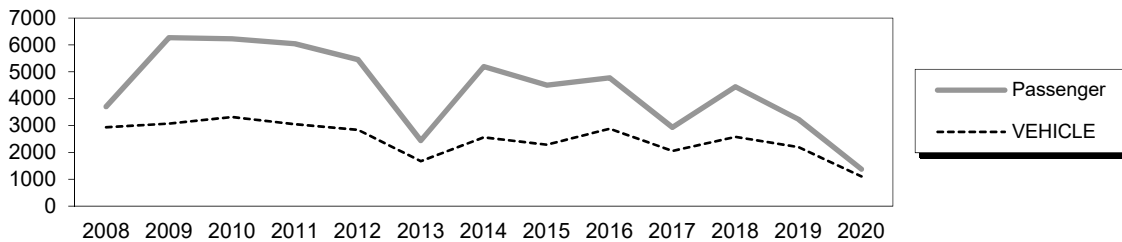
Terminal Description: Seldovia City Dock is a multi-purpose dock owned and operated by the City of Seldovia. The City & AMHS have an agreement for docking use. The dock is supported on steel pipe piling and has a steel and concrete superstructure with a steel wale, timber faced fender system. Vehicle access is via Dock Street and across a steel approach structure. There is a designated AMHS vehicle staging area (on City owned property), but no terminal building or other upland ferry terminal related facilities. This staging area does not appear to be utilized by ferry traffic. The dock and approach area has a fueling station, fuel storage facilities and serves as a freight wharf. The past 10 years of total passenger and vehicle traffic at Seldovia is shown below. The M/V Tustumena was out of service most of 2013, causing a steep dropoff in traffic at the terminal. The global pandemic caused the decline in 2020.

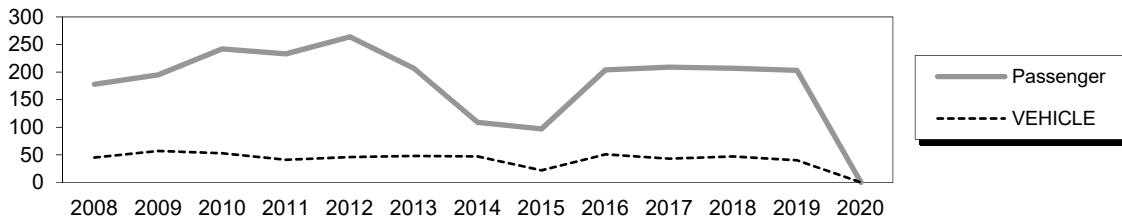
The past 12 years of total passenger and vehicle traffic at Tatitlek is shown below. Pedestrian and vehicle traffic in 2020 dropped to zero during the global pandemic.

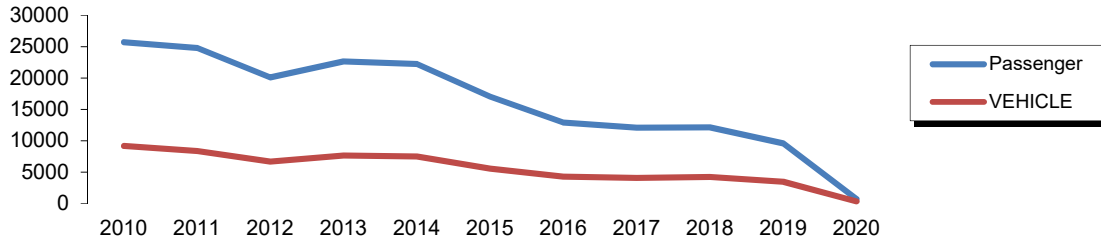
Terminal Description: Valdez is a side-loading facility consisting of a dedicated staging and parking areas, terminal building, covered pedestrian walkways, steel transfer bridge with a cable supported bridge lift (Syncrolift) system, eight steel pile dolphins and catwalks/gangways for line-handling access. The past 10 years of total passenger and vehicle traffic at Valdez is shown below.

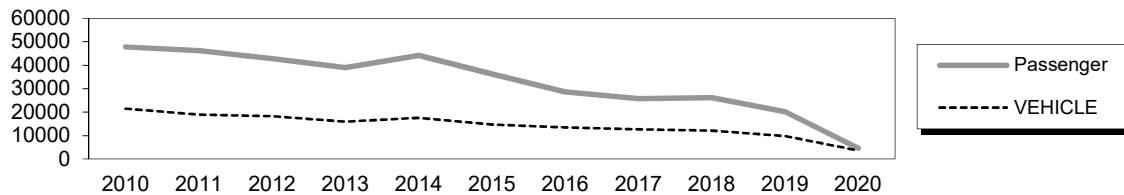
A single-lane highway tunnel and the Alaska Railroad provide access to Whittier from Anchorage and Portage. Like Valdez, this is a key connection point between Cordova and Anchorage. Tourism accounts for much of the summer traffic volume through this port. The facility went to year round service starting in 2005 with the reopening of the new modification project. The past 10 years of total passenger and vehicle traffic at Whittier is shown below.

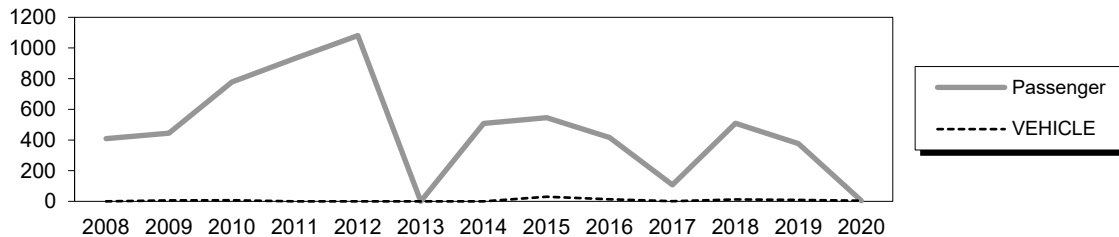
Terminal Description: The M/V TUSTUMENA docks in Akutan during its May through September Aleutian Chain trips. AMHS has previously discharged only passengers at this facility; however, sailings now include some vehicles. The Akutan City Dock is a platform dock constructed of concrete panels, steel pile caps and steel support piling. Abutting the back of the dock is an earth filled sheet pile bulkhead for the full length of the dock. There are two mooring dolphins with fender units on each side of the dock. In line with the western dolphins is a sheet pile wall that acts as a wave barrier for a small boat harbor, with a 50-foot extension installed in 2005. The past 12 years of total passenger and vehicle traffic at Akutan is shown below. Akutan had no/low ferry service in summers 2013 & 2017 while the M/V Tustumena was in the shipyard for repairs. The global pandemic caused the decline in 2020.

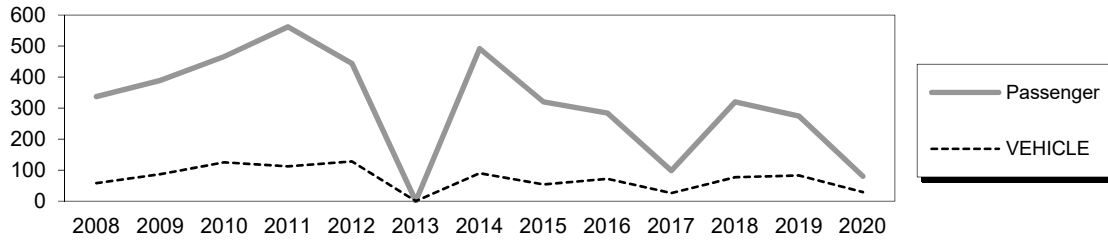
Terminal Description: The M/V TUSTUMENA docks at the newly built City Dock in Chignik during its May through September Aleutian Chain trips. The City Dock is an open-cell sheet pile bulkhead structure with steel pin-pile fender units and a mooring dolphin. The dock was built in 2017 and is connected to a 5-acre approach lot. The dock face is 282-ft long with five (5) fender units along its seaward face. The past 12 years of total passenger and vehicle traffic at Chignik is shown below. Chignik had no ferry service in summer 2013 while the M/V Tustumena was in the shipyard for repairs. The global pandemic caused the decline in 2020.

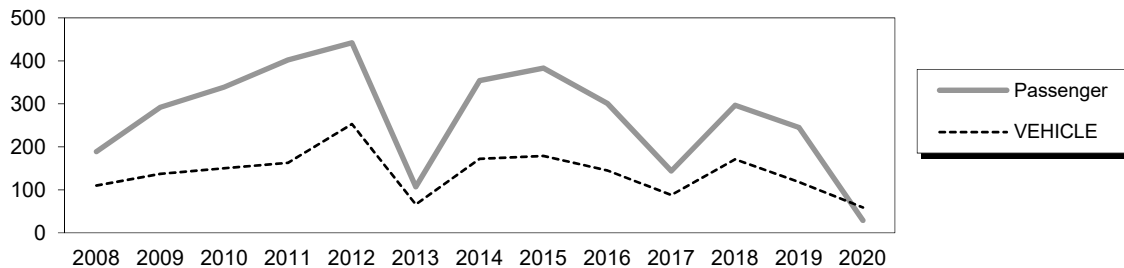
Terminal Description: The M/V TUSTUMENA docks at the Cold Bay Dock during its passage through the Aleutian Chain. The Cold Bay facility is made up of two dock sections that were constructed at different times. The original structure, designed and built by the State in 1978 consisted of a 100' x 40' concrete panel dock and a 1,320' long concrete panel approach. There is a mooring dolphin and catwalk northwest of the original dock. In 1993, a 360' x 60' addition was constructed to the northeast of the original dock; the newer dock abuts the face of the original structure. The facility is owned by the Aleutian East Borough and managed by the City of Cold Bay. The past 12 years of total passenger and vehicle traffic at Cold Bay is shown below. The M/V Tustumena was out of service most of 2013, causing a steep dropoff in traffic at the terminal. The global pandemic caused the decline in 2020.

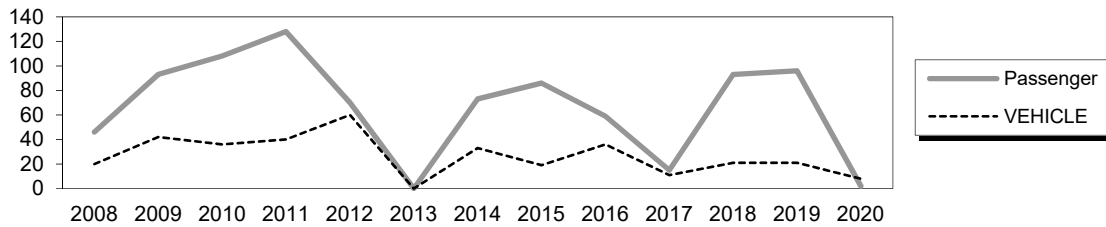
Terminal Description: The M/V Tustumena docks at the False Pass Dock during its passage through the Aleutian Chain. Service to False Pass was initiated in 1993. The False Pass facility consists of an L-shaped 175' x 40' dock, 450' long approach trestle, with a mooring dolphin located on each end of the dock and connected via a steel catwalk. There is a 100' x 100' staging area upland of the dock. The facility is a multi-purpose facility and could be in use by other vessels when the ferry arrives. AMHS is not in control of the operation or maintenance of this facility. The past 12 years of total passenger and vehicle traffic at False Pass is shown below. False Pass had no ferry service in summer 2013 while the M/V Tustumena was in the shipyard for repairs. The global pandemic caused the decline in 2020.

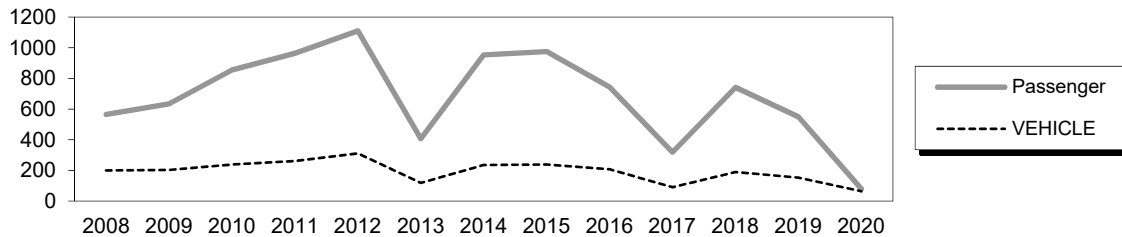
Terminal Description: The M/V Tustumena docks at the Aleutians East Borough facility in King Cove on its passage through the Aleutian Chain. The King Cove facility consists of a sheet pile bulkhead structure with a face approximately 125' long. There are 4 steel pile mooring dolphins (two on each side of the dock) connected to the dock by steel catwalks. Access to the dock is via an embankment and paved roadway. There is a breach in the embankment at about its midpoint to permit juvenile fish migration. A steel girder/concrete deck bridge spans the breach; sheet pile cells protect the abutments. The facility is a multi-purpose facility and could be in use by other vessels when the ferry arrives. AMHS is not in control of operation or maintenance of this facility. The past 12 years of total passenger and vehicle traffic at King Cove is shown below. The M/V Tustumena was out of service most of 2013, causing a steep drop-off in traffic at the terminal. The global pandemic caused the decline in 2020.

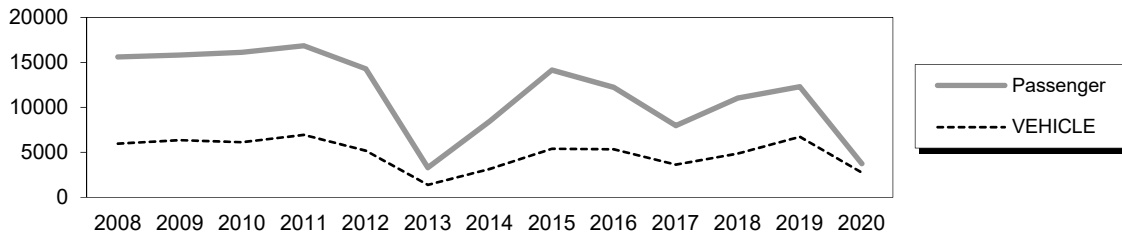
Terminal Description: The M/V Tustumena docks at the Kodiak City Dock (also called Pier 1) on its east/west passage between Homer and the Aleutian Chain. The Kodiak City Dock structure is supported by steel pipe piles, with concrete pier caps, p/c concrete channel beams (approach), & p/c concrete haunched deck panels (main dock). The fender system consists of five pin-pile supported fender panels. The facility is a U-shaped concrete structure with a main dock section approximately 230'x 25', and two 103' approach trestles, one at each end of the dock. The dock is currently used for transfer of general cargo and fuel, in addition to ferry operations. The paved area between the street and the terminal building has a shared use for parking and vehicle staging. Embarking vehicles line up on the adjacent city street, in the paved area and along the 75'-wide north approach trestle. The contractor operated ticket office is located in a city owned building, on shore, between the two approach trestles. The wharf is crowded between a marine fuel service depot to the north and a shore based seafood processor to the south. Vessels moored at the adjacent facilities encroach on berthing the dock. The past 12 years of total passenger and vehicle traffic at Kodiak City Dock is shown below. The M/V Tustumena was out of service most of 2013, causing a steep drop in traffic at the terminal. The global pandemic caused the drop in 2020.

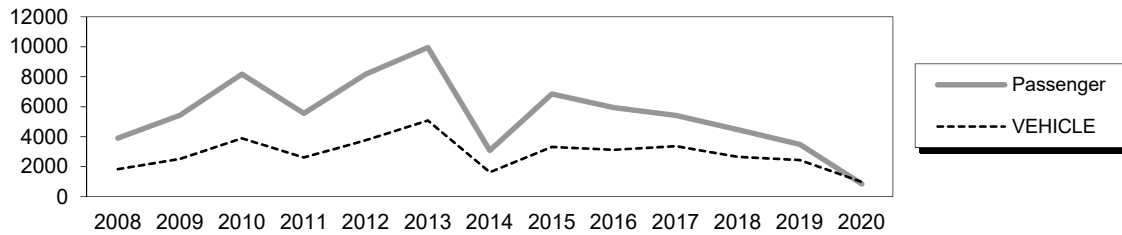
The past 12 years of total passenger and vehicle traffic at Kodiak Pier 2 is shown below. The M/V Kennicott was only in service for 7 months in 2014, resulting in a steep drop-off in traffic at the terminal. The global pandemic caused the drop in 2020.

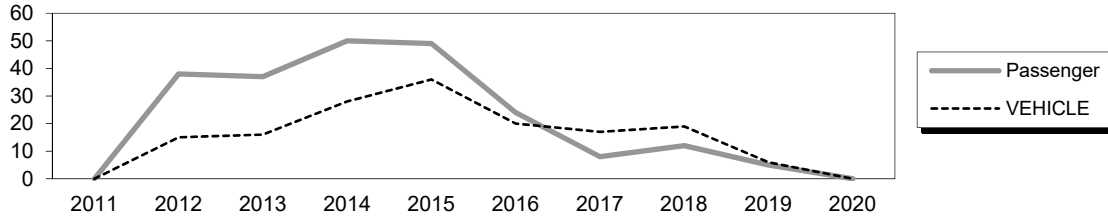
Terminal Description: Old Harbor City dock is a multi-use dock facility on Kodiak Island (50 miles southwest of City of Kodiak). The dock was built in 2012 to replace the aging timber freight dock. The M/V Tustumena provides ferry service to the dock. The facility consists of a 55'x102' pile-supported dock with 3 fender panels, 3 mooring dolphins with access to the dock by steel catwalks, and an 18'x 280' pile-supported approach trestle connected to shore. AMHS is not in control of operation or maintenance of this facility. The most recent annual passenger and vehicle traffic at Old Harbor is shown below.

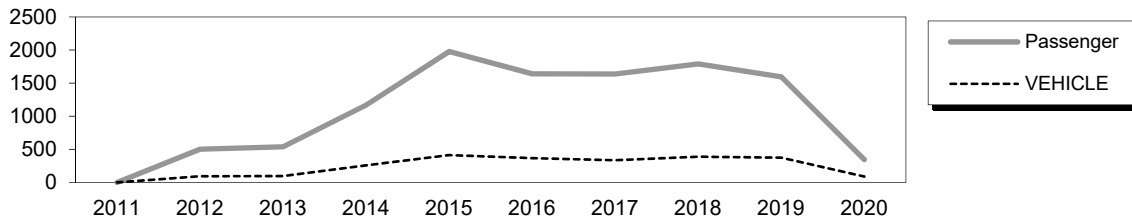
Terminal Description: The M/V Tustumena stops in Ouzinkie, on Spruce Island (15 miles northwest of Kodiak) as part of its scheduled voyage between Kodiak and Homer. This is a new port of call for AMHS as of 2012. The open-cell sheet pile wharf was built in 2012 to replace an aging timber dock. The ship breasts against four (4) fender panels on the 175-foot long southeast dock face. This is a multi-purpose facility utilized by other vessels. AMHS is not in control of operation or maintenance. The most recent annual passenger and vehicle traffic at Ouzinkie is shown below. The global pandemic caused the decline in 2020.

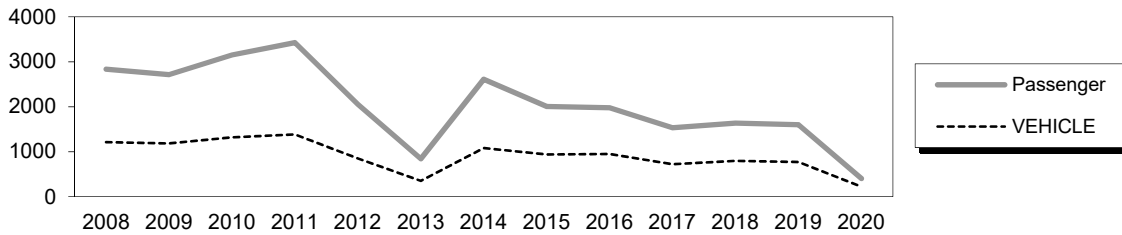
Terminal Description: The M/V Tustumena docks at Port Lions on its passage between Kodiak and Homer. Port Lions is the second busiest port of call along the southwest route after Kodiak. The Port Lions facility is an earth-filled sheet pile bulkhead constructed in 2014. The dock has a 214' berthing face with two mooring dolphins along the north end. Access to the dock is via a rubble-mound breakwater. The facility is a multi-purpose dock and could be in use by other vessels when the ferry arrives. AMHS is not in control of the operation or maintenance of this facility. The past 12 years of total passenger and vehicle traffic at Port Lions is shown below. The M/V Tustumena was out of service most of 2013, causing a steep drop-off in traffic at the terminal. The global pandemic caused the decline in 2020.

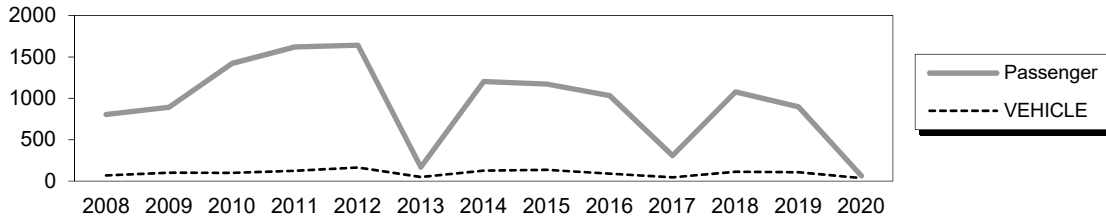
This is a multi-purpose facility utilized by other vessels. AMHS is not in control of operation or maintenance. The past 12 years of total passenger and vehicle traffic is shown below. The M/V Tustumena was out of service most of 2013 & 2017, causing steep drop-offs in traffic at the terminal. The global pandemic caused the decline in 2020.

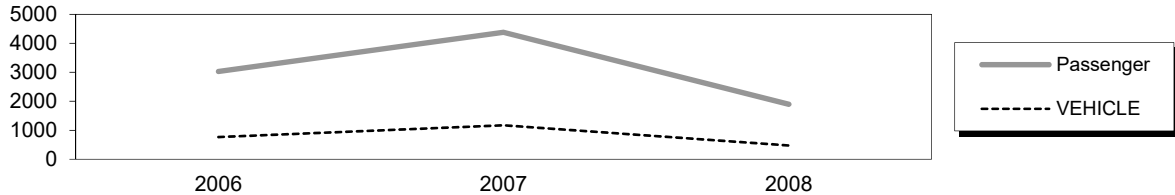
Terminal Description: Coffman Cove is a stern-loading facility consisting of a terminal building, maintenance shop, paved parking area, secure (fenced) staging area, steel approach trestle, transfer bridge, steel support float and four steel pile all-tide mooring dolphins. The Coffman Cove facility, constructed in 2006, serves the Prince of Wales Island communities by linking them via the IFA’s M/V Prince of Wales to AMHS mainline service in Petersburg. The IFA northern route has not been operational since 2008. Coffman Cove’s total passenger and vehicle traffic from 2006 through 2008 is shown below.

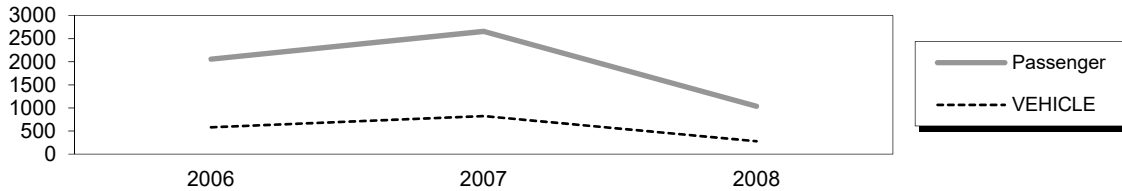
Terminal Description: South Mitkof is a side-loading facility constructed in 2006 consisting of a modular ticketing office, secure (fenced) staging area, 900-foot long steel approach, steel transfer bridge, steel support float and six steel pile mooring dolphins. The IFA northern route has not been operational since 2008. South Mitkof's total passenger and vehicle traffic between 2006 and 2008 is shown below.
